## Chatter or Rattle Near Left or Right Door Tweeter

### AFFECTED VEHICLES

2017 NSX

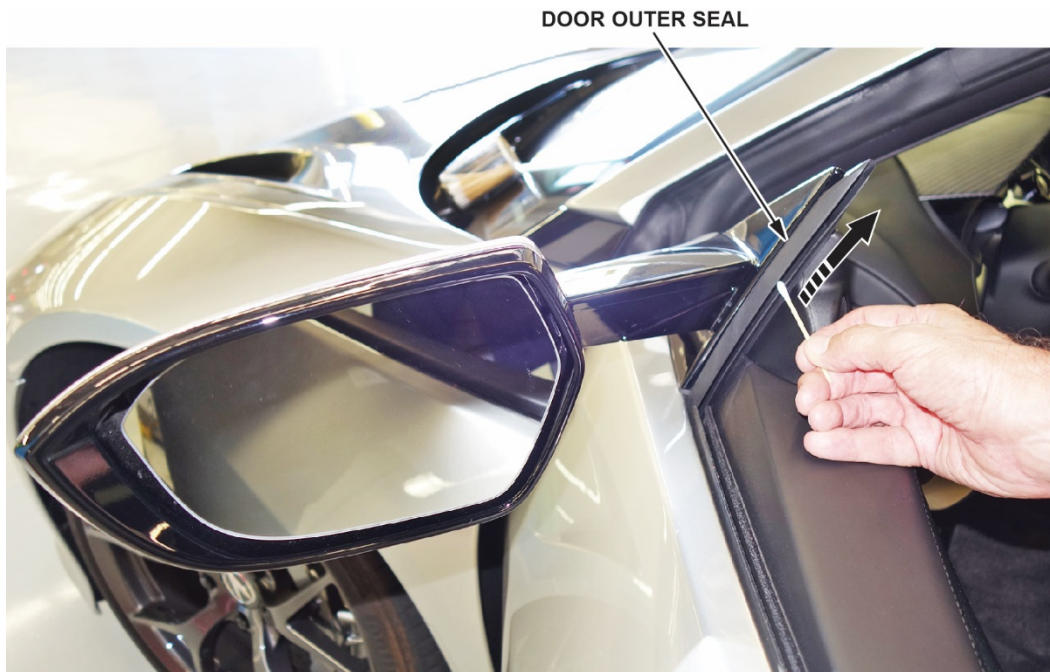
When driving on a rough road, are you hearing a chatter or rattle that seems to be coming from near the left or right door tweeter, close to the base of the A-pillar? Chances are the door outer seal (window run channel) is causing it.

To quiet things down, apply a thin, even layer of Shin-Etsu Silicone Grease (P/N 08798-9013) to the inner edges of the seal with Q-tips, then raise and lower the window glass several times. Be sure to wipe off any excess grease you see with the window raised.
