Multiple Indicators and MIL On with A/T DTC P26C3

AFFECTED VEHICLES

2016–17 MDX, 2017 NSX, 2014–17 RLX Sport Hybrid, and 2015–17 TLX

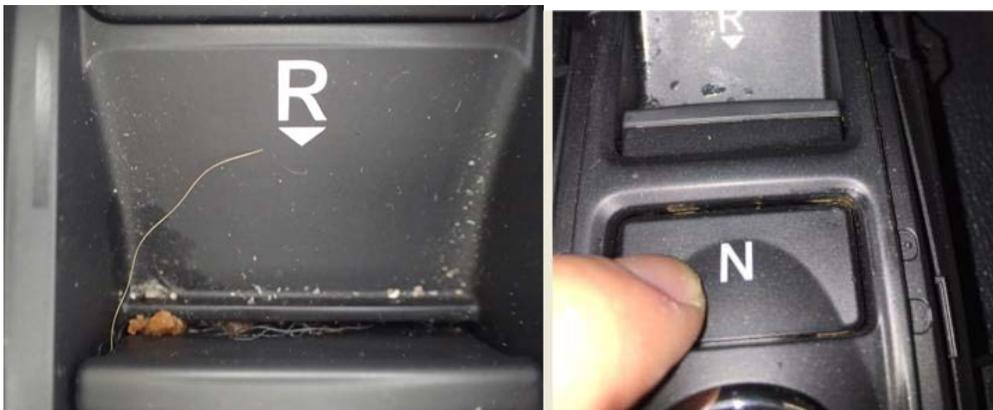
Do you have a vehicle that has multiple indicators on or won't go into gear and the MIL is on with A/T DTC P26C3 (internal control module transmission range sensor performance)? There may be debris in the Reverse or Neutral shift buttons of the shift by wire (SBW) shifter assembly that's causing them to stick. Typical debris are particles in the Reverse shift button or sticky residue in the Neutral shift button from something that spilled.

1. Check for debris in either shift button.
 - If you find particles in the Reverse shift button, pull it back and remove them either with a vacuum or a pair of tweezers. If you find sticky residue in the Neutral shift button, remove the residue with a clean cloth dampened with fresh water. When you're done, go to step 2.

- NOTE:** Avoid using liquids, chemicals, or pressurized air to remove debris; you could damage the buttons. Also, be sure to let the service consultant know that you found debris so he or she can educate your client on just how seriously it can affect transmission performance.

- If you don't find any debris in either shift button, go to step 2.
2. With the engine shut off, work each shift button of the SBW shifter assembly one at a time.

- If any shift button is hard to press, slow to return, or doesn't fully return, replace the SBW shifter assembly, then go to step 3.
 - If all of the shift buttons work OK, go to step 3.

3. Clear the DTC, start the engine, and with the parking brake set and the brake pedal pressed, work the Park, Reverse, Neutral, and Drive shift buttons one at a time, waiting **15 seconds** between each gear change. Then, repeat this three more times, and wait **2 minutes** before shutting off the engine.
 - If the DTC doesn't reset and the transmission shifts normally, you're done.
 - If the DTC resets or the transmission doesn't shift normally, replace the SBW shifter assembly.
